Management and Maintenance Manual  
The Old Hospital Complex  
Fort Carson, Colorado  
(5EP1778)

James Schneck

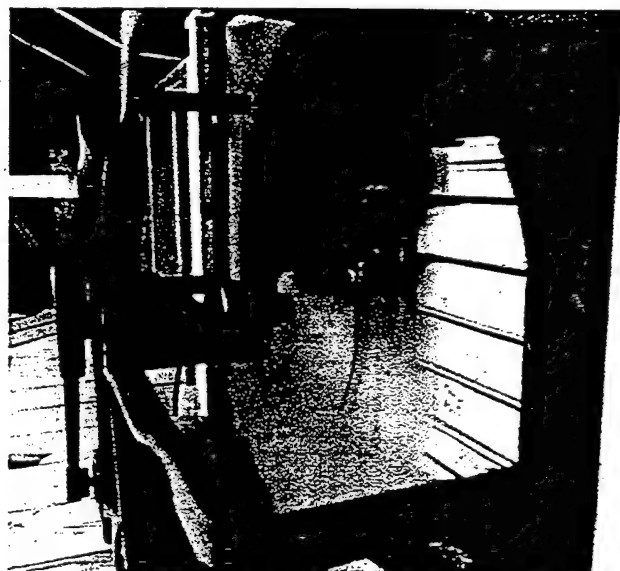
9. Improving ventilation through traditional means should not be overlooked in planning new or upgraded HVAC systems. In mild climates, good exhaust fans can often eliminate the need for air conditioning or can reduce equipment size by reducing cooling loads. Photo: Ernest A. Conrad, P.E.

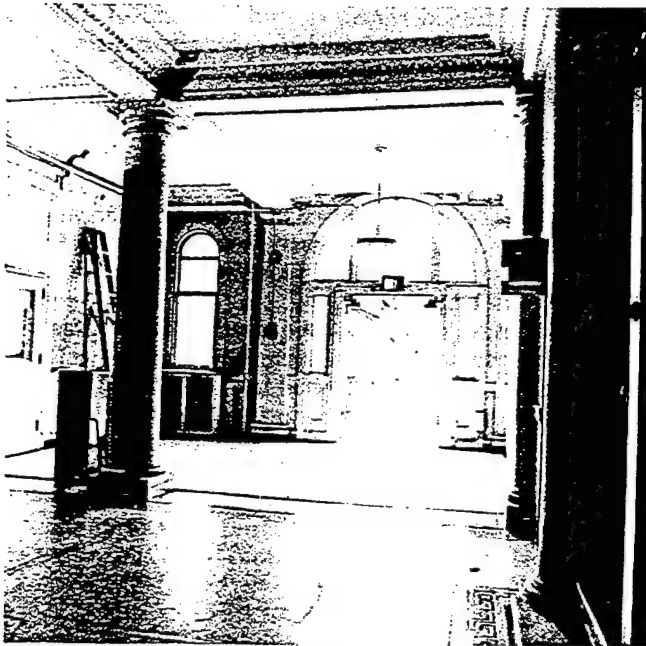
10. The following photographs illustrate recent preservation projects where careful planning and design retained the historic character of the resources.

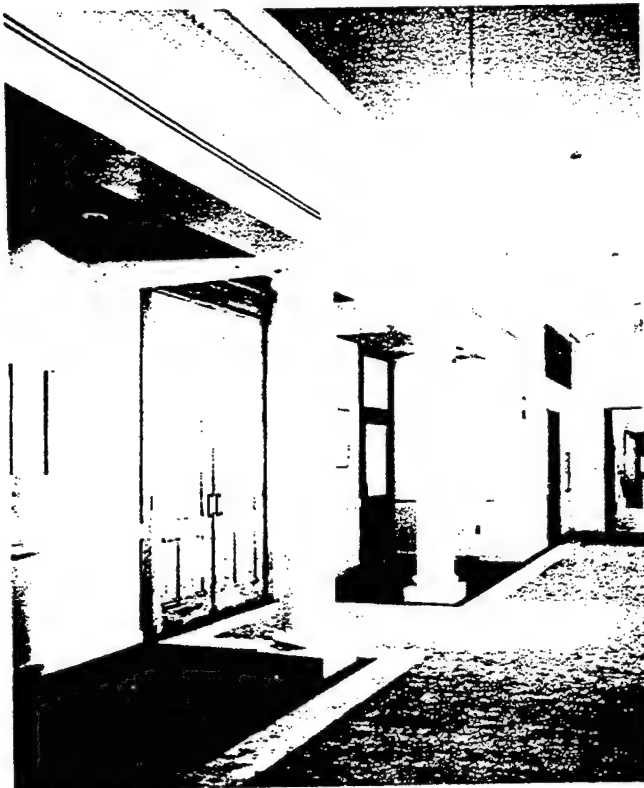
b. Central air conditioning was installed in the corridors of this circa 1900 school building by adding an air handler over the entrance from a vestibule. The custom-designed slot registers provide linear diffusers without detracting from the architecture of the space. Photo: Lautman Photography courtesy of Notter Finegold + Alexander Inc.

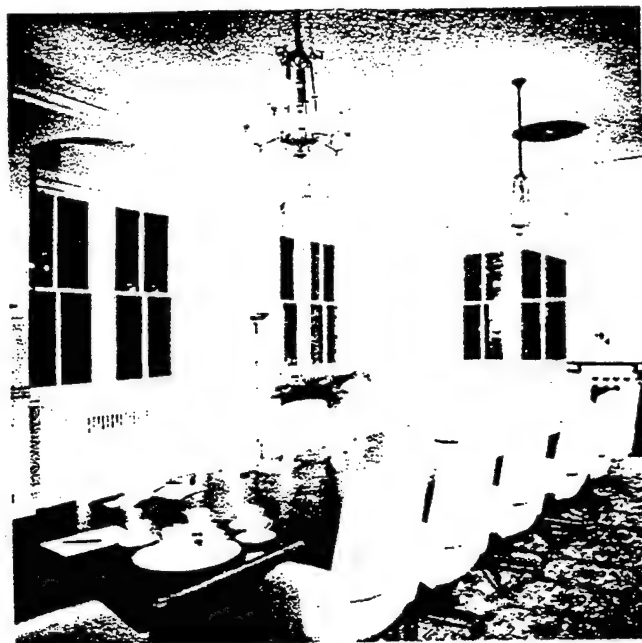
c. Conference room, Auditors Building, Washington, D.C. The historic steam radiators were retained for heating. The cast iron ceiling register was retained as a decorative element, but made inoperable to meet fire codes. Photo: Kenneth Wyner Photography courtesy of Notter Finegold + Alexander Inc.

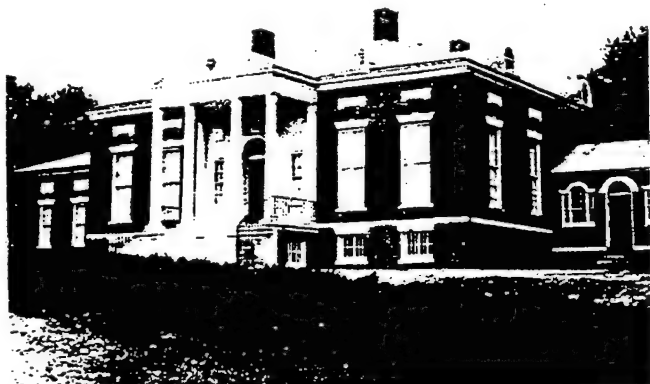
Too often the presumed climate needs of the occupants or collections can be detrimental to the long-term preservation of the building. With a careful balance between the preservation needs of the building and the interior temperature and humidity needs of the occupants, a successful project can result.

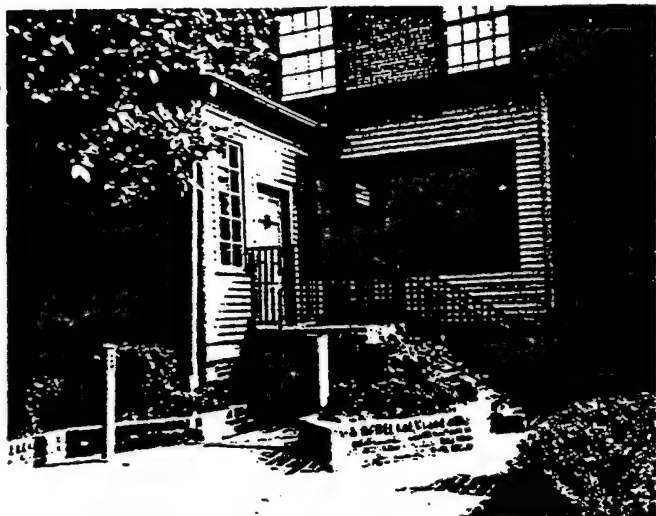
Figure 14. At the Lieutenant Governor's Mansion in Frankfort, Kentucky, a retracting lift (b) was installed to minimize the visual effect on this historic building when not in use (a). Photos: Aging Technology Incorporated.

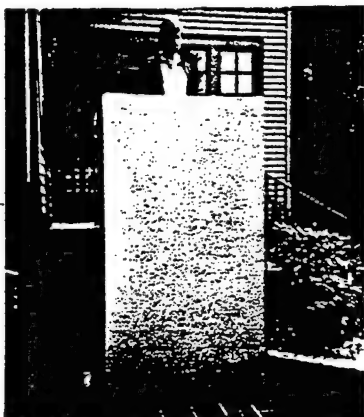
Figure 15. A new entrance to the elevator lobby replaces a window at Faneuil Hall in Boston, Massachusetts. The new entrance is appropriately differentiated from the historic design. Photo: Paul Holtz.

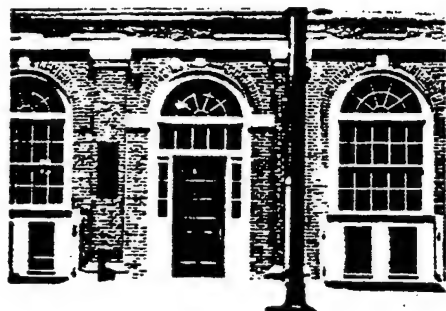
(operated by push buttons, mats, or electronic eyes) and power-assisted door openers can eliminate or reduce door pressures that are accessibility barriers, and make single or double-leaf doors fully operational (See Figure 16).

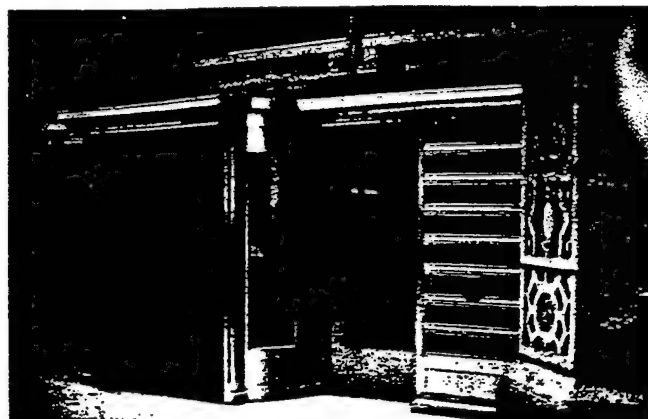
Figure 16. During the rehabilitation of the Rookery in Chicago, the original entrance was modified to create an accessible entrance. Two revolving doors were replaced with a new one flanked by new doors, one of which is operated with a push-plate door opener. Photo: Thomas Jester.

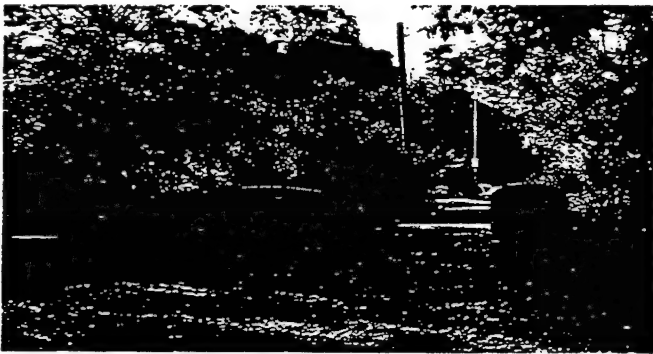
(a.) To improve accessibility in Boston's Emerald Necklace Parks, standard asphalt paving was replaced in selected areas with an imbedded aggregate surface that is more in keeping with the landscape's historic appearance. Photo: Charles Birnbaum.

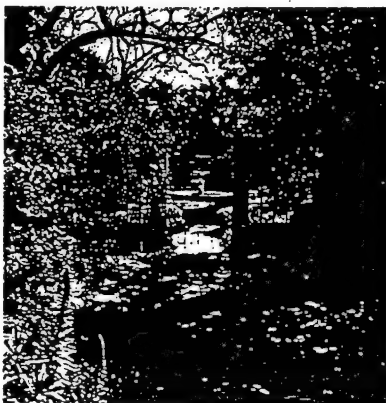
(b.) The Friendly Garden at Rancho Los Alamitos, a historic estate with designed gardens in southern California, was made accessible with limited widening of its existing approach path. Photo: Rancho Los Alamitos Foundation.

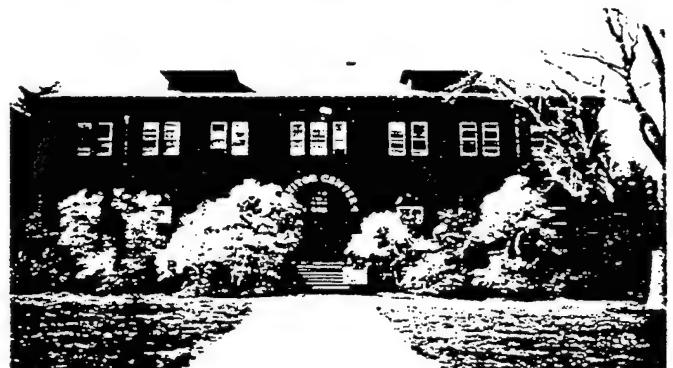
(c.) Hunnewell Visitor's Center before rehabilitation, revealing the altered landscapes. Photo: Jennifer Jones, Carol R. Johnson and associates.

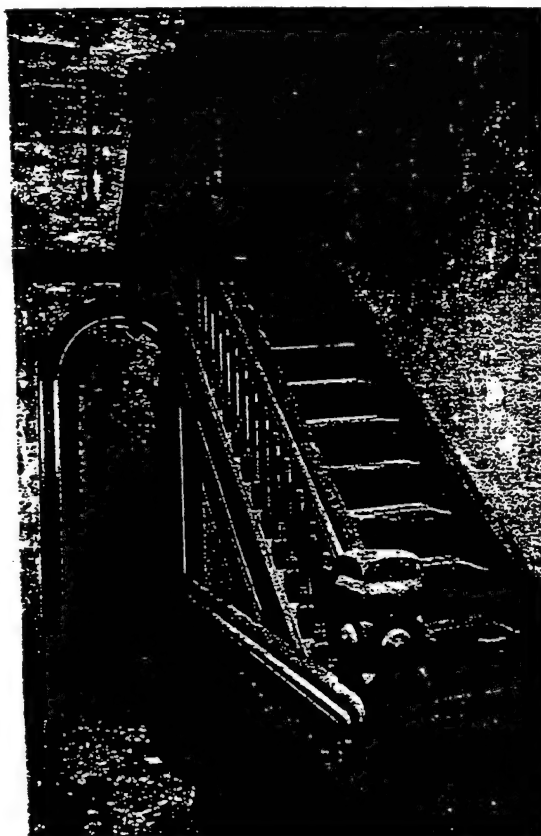
The premise of this Preservation Brief is that historic housing can be made lead-safe for children without removing significant decorative features and finishes, or architectural trimwork that may contribute to the building's historic character (see fig. 1). *Historic housing* — encompassing private dwellings and all types of rental units—is necessarily the focus of this Brief because federal and state laws primarily address the hazards of lead and

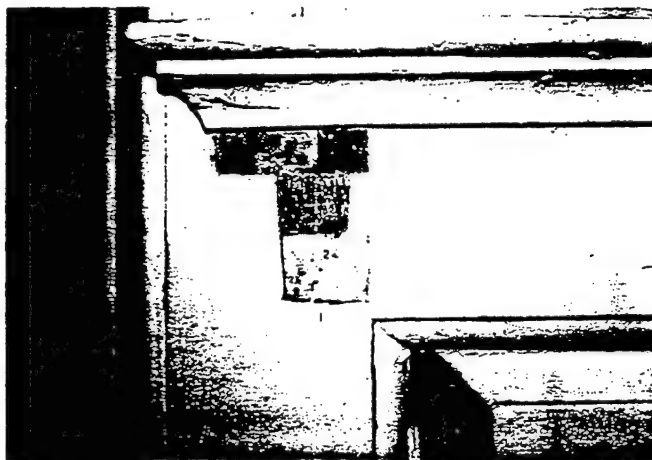
Figure 2. The paint chronology of this mantel, seen in the exposed paint layers in the left corner, proved it had been relocated from another room in the house. To remove a significant feature's paint history and the evidence of its original sequence of color by stripping off all the paint is inappropriate — and unnecessary — as part of a lead hazard reduction project. Careful surface preparation and repainting with lead-free top coats is recommended. Photo: NPS Files.

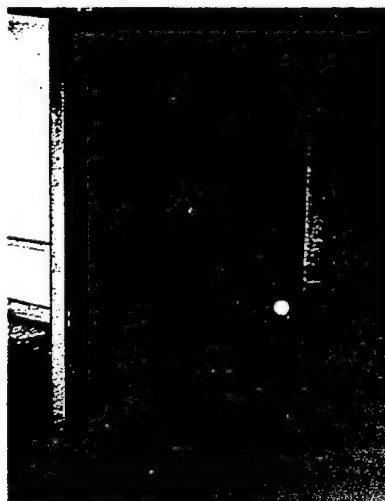
Figure 3. Significant architectural features and their finishes should not be removed during a project incorporating lead hazard controls. If the decorative stencilling above, or hand grained doors below, or painted murals need repair, then a paint conservator should be consulted. Once loose paint is consolidated or otherwise stabilized, a clear finish or other reversible clear protective surface or coating can be added to areas subject to impact or abrasion. Photos: NPS Files.

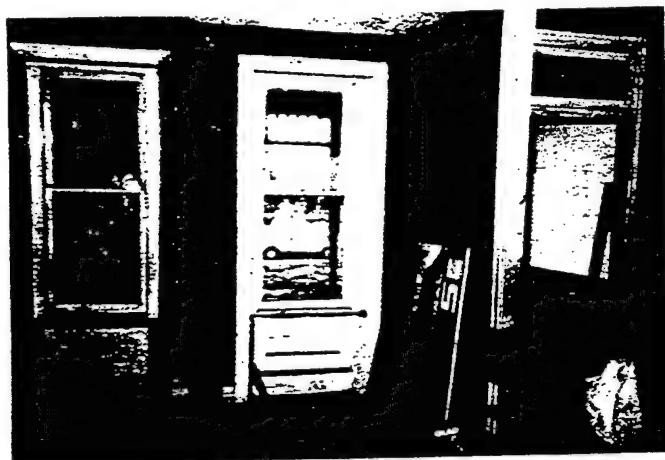
The historical significance, integrity, and architectural character of the building always need to be assessed before work is undertaken that might adversely affect them. An owner may need to enlist the help of a preservation architect, building conservator or historian. The State Historic Preservation Office (SHPO) may be able to provide a list of knowledgeable preservation professionals who could assist with this evaluation.

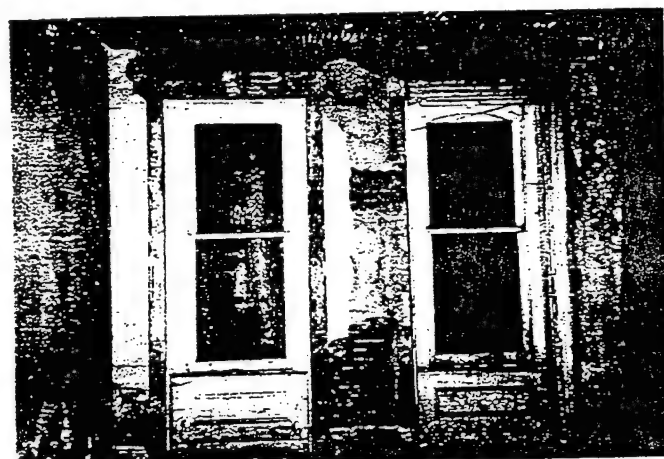
Figure 4. The typical method for abating lead-based paint through substrate removal is not consistent with the Standards for Rehabilitation. In this project, all the historic trim, base panels, and the transom were removed. While the unit is lead-safe, its character has been severely altered. Figure 5 shows a similar, but successful, balance of historic preservation and lead hazard control work. Photo: NPS Files.

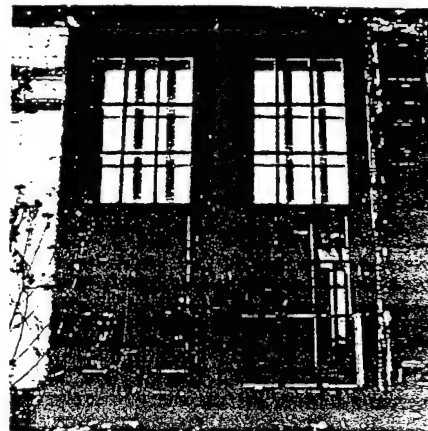
*Figure 7. Chalking exterior paint can cause dangerous lead levels in soil around a house. Lead levels are usually highest in the one foot wide area adjacent to the building foundation. In these cases, the existing soil should be replaced with new soil or sod. This is particularly important if children and small pets play in contaminated areas, then inadvertently track the dirt inside.*

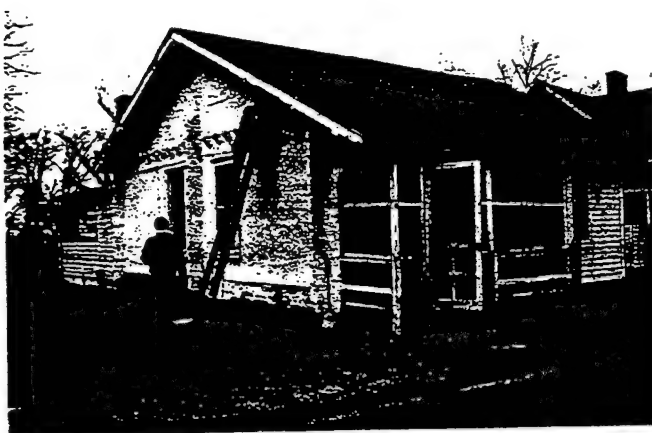
This hierarchy gives an owner a working guide for making decisions about appropriate methods of removing lead paint.

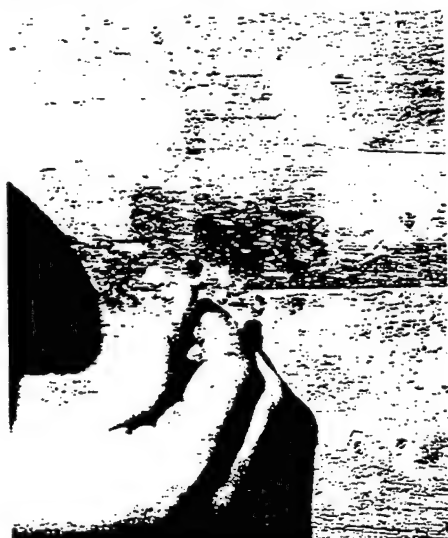
- the paint's location
- the paint's condition
- lead content of paint and soil
- the type of surface (friction; accessible to children for chewing; impact)
- how much lead dust is actively present
- how the family uses and cares for the house
- the age of the occupants who might come into contact with lead paint.

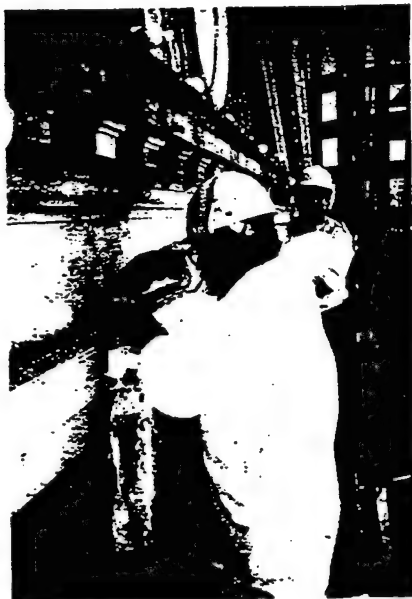
Figure 10. The choice of paint removal method will trigger various environmental controls and worker protection. The chemical poultice-type paint remover uses a paper backing that keeps the lead waste contained for proper disposal. The worker is adequately protected by a suit and gloves; for this work a respirator was not required. Local laws required containment and neutralization of any after-wash water run off. Photo: NPS Files.

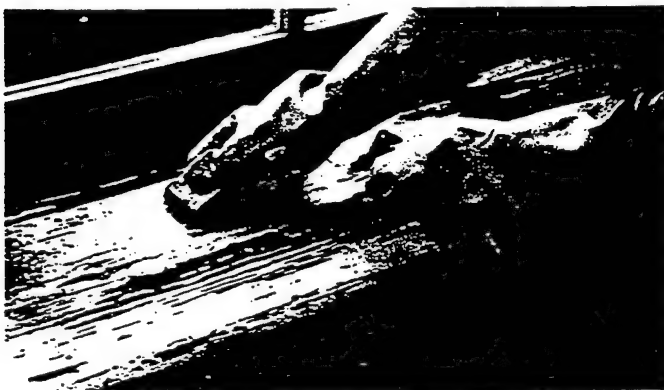
Figure 15. Wet sanding of interior surfaces will keep dust levels down, reduce the need for workers' protection, and provide a sound surface for repainting. Priming and repainting with oil/alkyd, latex or latex acrylic should be undertaken according to manufacturers' instructions.

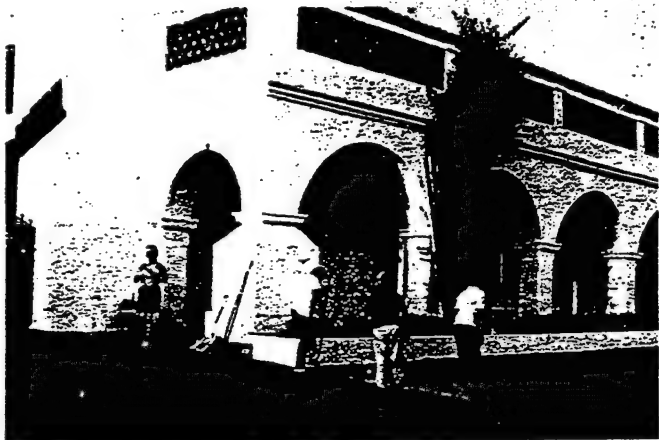
Figure 17. When historic sites are found to contain high levels of lead in bare soil — particularly around foundations — it is important to reduce the hazard without destroying significant landscapes. In many cases, contaminated soil can be removed from the foundation area and appropriate plantings or ground covers replanted in new soil. Photo: Charles A. Birnbaum, ASLA.

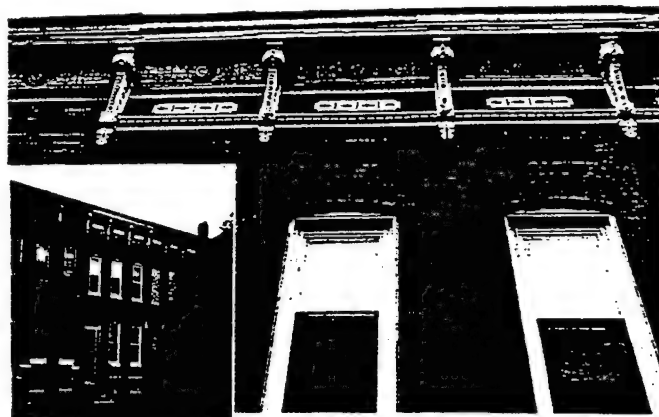
Figure 18. As part of an urban housing grant program, the exterior of this row house was successfully made lead-safe and met the Secretary of the Interior's Standards for Rehabilitation. The exterior was washed, then repainted with exterior grade alkyd paint. The decorative roof brackets and cornice were repainted; not removed or covered as is often recommended in typical abatement guidelines. The previously altered, deteriorated window sash were replaced with new sash and jamb liners set within the historic frames. Photos: Deborah Birch.

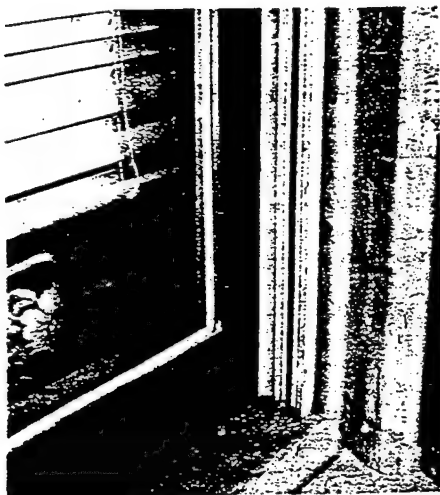
Figure 20. Operable windows have friction surfaces between the sash and the frames, which can be a source of fine lead dust. In this case, the deteriorated sash was replaced, but the historic frame remains in place, successfully isolated from the sash with a simple vinyl jamb liner that is part of the new sash operation.

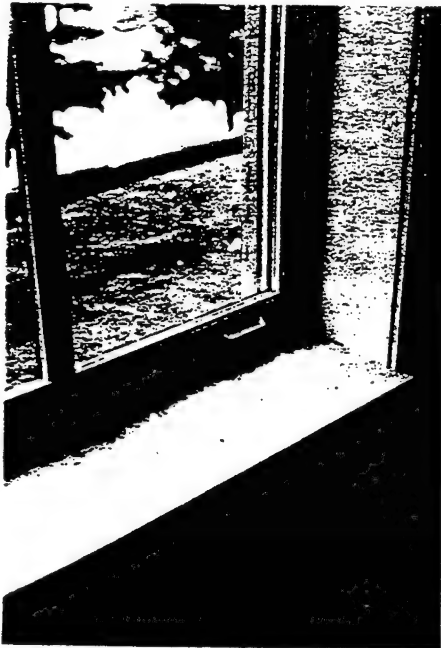
Figure 22. Research has shown that some small children will chew on projecting window sills while teething. As part of a lead hazard control project, the edge of the sill can be stripped to bare wood or an encapsulating paint applied. In this case, a new window sill was installed as part of a window upgrade that retained the historic trim and frame.

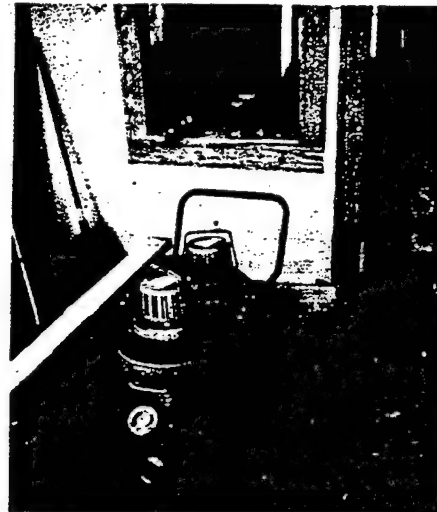
Figure 24. Historic baseboards are often bumped by brooms and vacuum cleaners, causing lead-based paint chips to fall on the floor. Shoe moldings can be added or replaced to increase protection to the baseboard itself. In this case, because the condition of the interior warranted substantial repair, simple historic board trim was replaced with new matching trim. Note the HEPA filter vacuum in the foreground. Photo: NPS file.

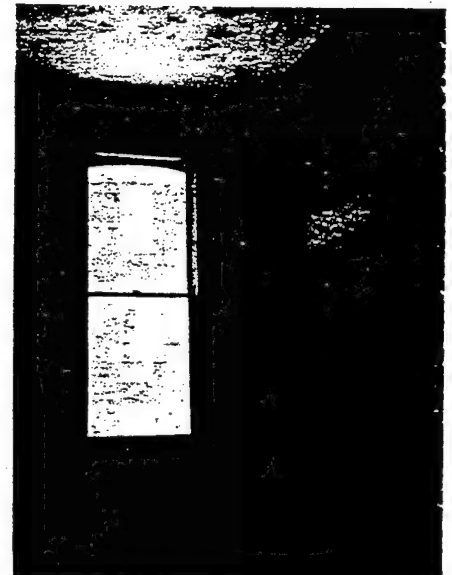
If a new drywall surface needs to be applied, care should be taken that the historic relationship of wall to trim is not lost. Also, if there are significant features, such as crown moldings or ceiling medallions, they should always be retained and repaired (see fig. 26).

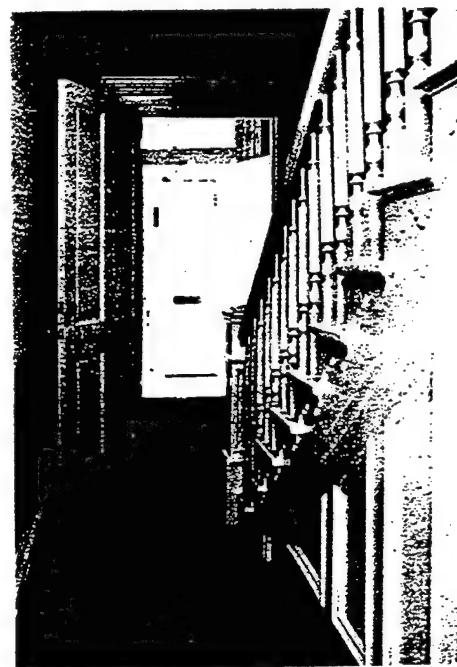
Photographs courtesy of the authors unless identified.
